## Jaguar / RR Discovery 4 IMMO emulator

Range Rover Discovery 4 (L319) - LR4  
 Range Rover Sport (L320 – 2010 up)  
 Range Rover (L322: 2010 up, L405 up to 2014)  
 Jaguar XF (X250), XJ (X351), XK (X150): 2008 ... 2015

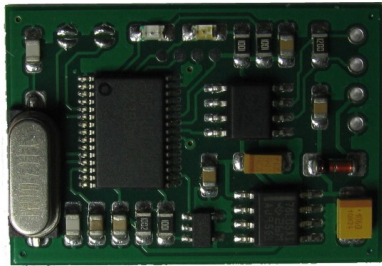
Designed for ECU authorization. Emulator is NOT Plug&Play, must store 8-byte SYNC before usage.

- **open** for CFG mode,
- **short** for normal mode (SYNC locked).

- **open** for all 2009 up,
- **short** for first years (2008...2009)

- **RED**: ecu is NOT authorized
- **GREEN**: ecu is authorized.

- JMP1 on emulator board must be open to allow configuration mode and SYNC update, set JMP2 according to specification,
- launch configurator software (same as for FORD Type-1 systems used), enter SYNC, press "Proceed". You will see 2 CAN messages on screen. If MBcan is already attached messages are transmitted to CAN immediately. If success SYNC field goes green. Otherwise store SYNC into emulator using any suitable CAN logger by sending these 2 messages at 500 Kbaud, STD ID. Check response - must receive 7FF (8) with actually stored SYNC – it must match, in addition both RED and GREEN LEDs on emulator board must go on for 1 second.
- Note that SYNC in ECU eeprom / d-flash is stored in reverse order.

- Must attach four wires: CAN-Hi, CAN-Lo, GND (ground), +IGN (terminal "15"). You may install emulator anywhere close to HS-CAN network and necessary power wires - inside ECU, near OBD connector etc.
- If engine is authorized and car starts, switch everything off and place solder joint(s) on emulator board to short JMP1 to avoid any updates by accident. Job done!
